NATIONAL BUREAU OF STANDARDS REPORT

5313

STRENGTH AND RIGIDITY OF LAP WELDED SPLICES
IN PRECAST REINFORCED CONCRETE FRAMING MEMBERS

Bureau of Yards and Docks
Department of the Navy

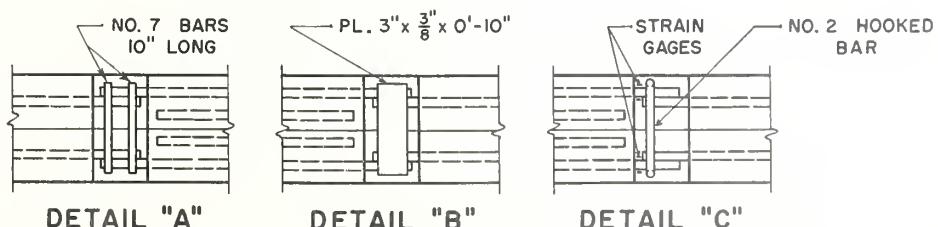
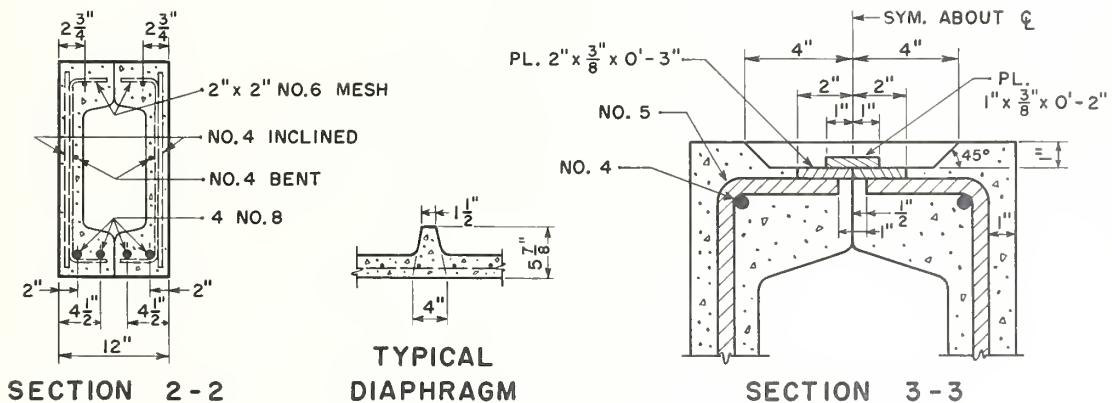
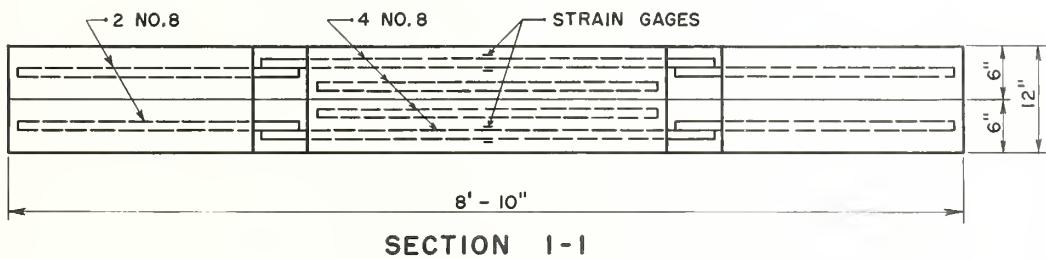
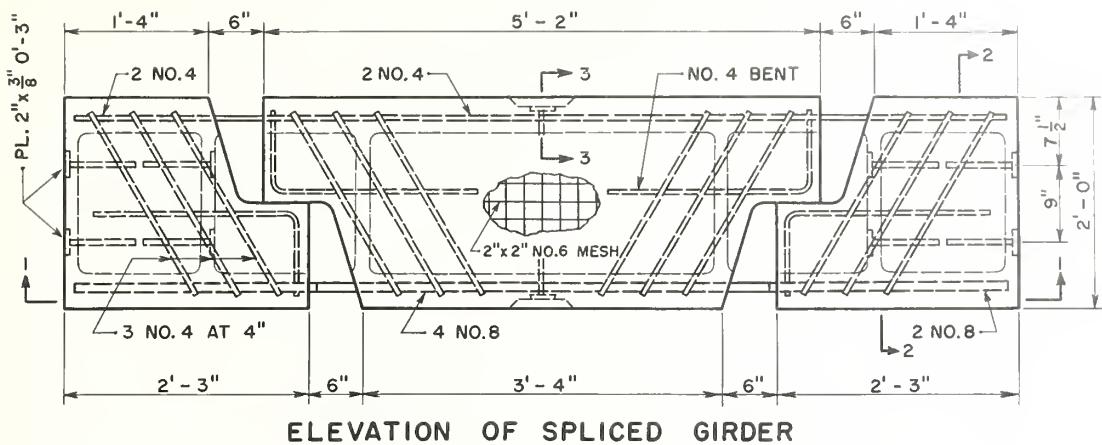
FIG. 1

The type of specimen selected for this test was a combination of the modified center section of "Precast Continuous Girder," (BuY&D sketch B-3, dated 5-3-53), and the end blocks of the "Tee Head," (BuY&D sketch B-1, dated 1-12-53). This combination produced a six element specimen with four welded splices. The cross section of the girder was 1- by 2 ft and the length was 8 ft 10 in. Each element was essentially channel shaped in cross section as can be seen in the detail sketch of the resulting composite box girder shown in figure 1.

Transverse reinforcement was added to the welded splices in girder No. 1. Two No. 7 bars 10 in. long were selected to reinforce one of the splices and an equal volume of steel in the form of a plate 3- by 3/8- by 10 in. long of intermediate grade steel was used to reinforce the other. The welding was completed as indicated in detail views A and B of figure 1, by a qualified Navy welder. The transverse reinforcement added to the welded splices of girders Nos. 3 and 4 consisted of a single No. 2 bar that was tack welded in place simply to keep it in position during the grouting operation. Detail view C of figure 1 indicates the location of this bar. Girder No. 2 did not contain transverse reinforcement.

The arrangement of longitudinal and web reinforcement is shown in figure 1. The reinforcement in the lower flanges of the center sections of each girder consisted of four No. 8 deformed bars. The two inner bars in the flanges of the channel sections were completely embedded while the outer bars extended 5 in. beyond the edge of the concrete. Similarly, the upper flanges of the center sections of each girder were reinforced with No. 4 bars.

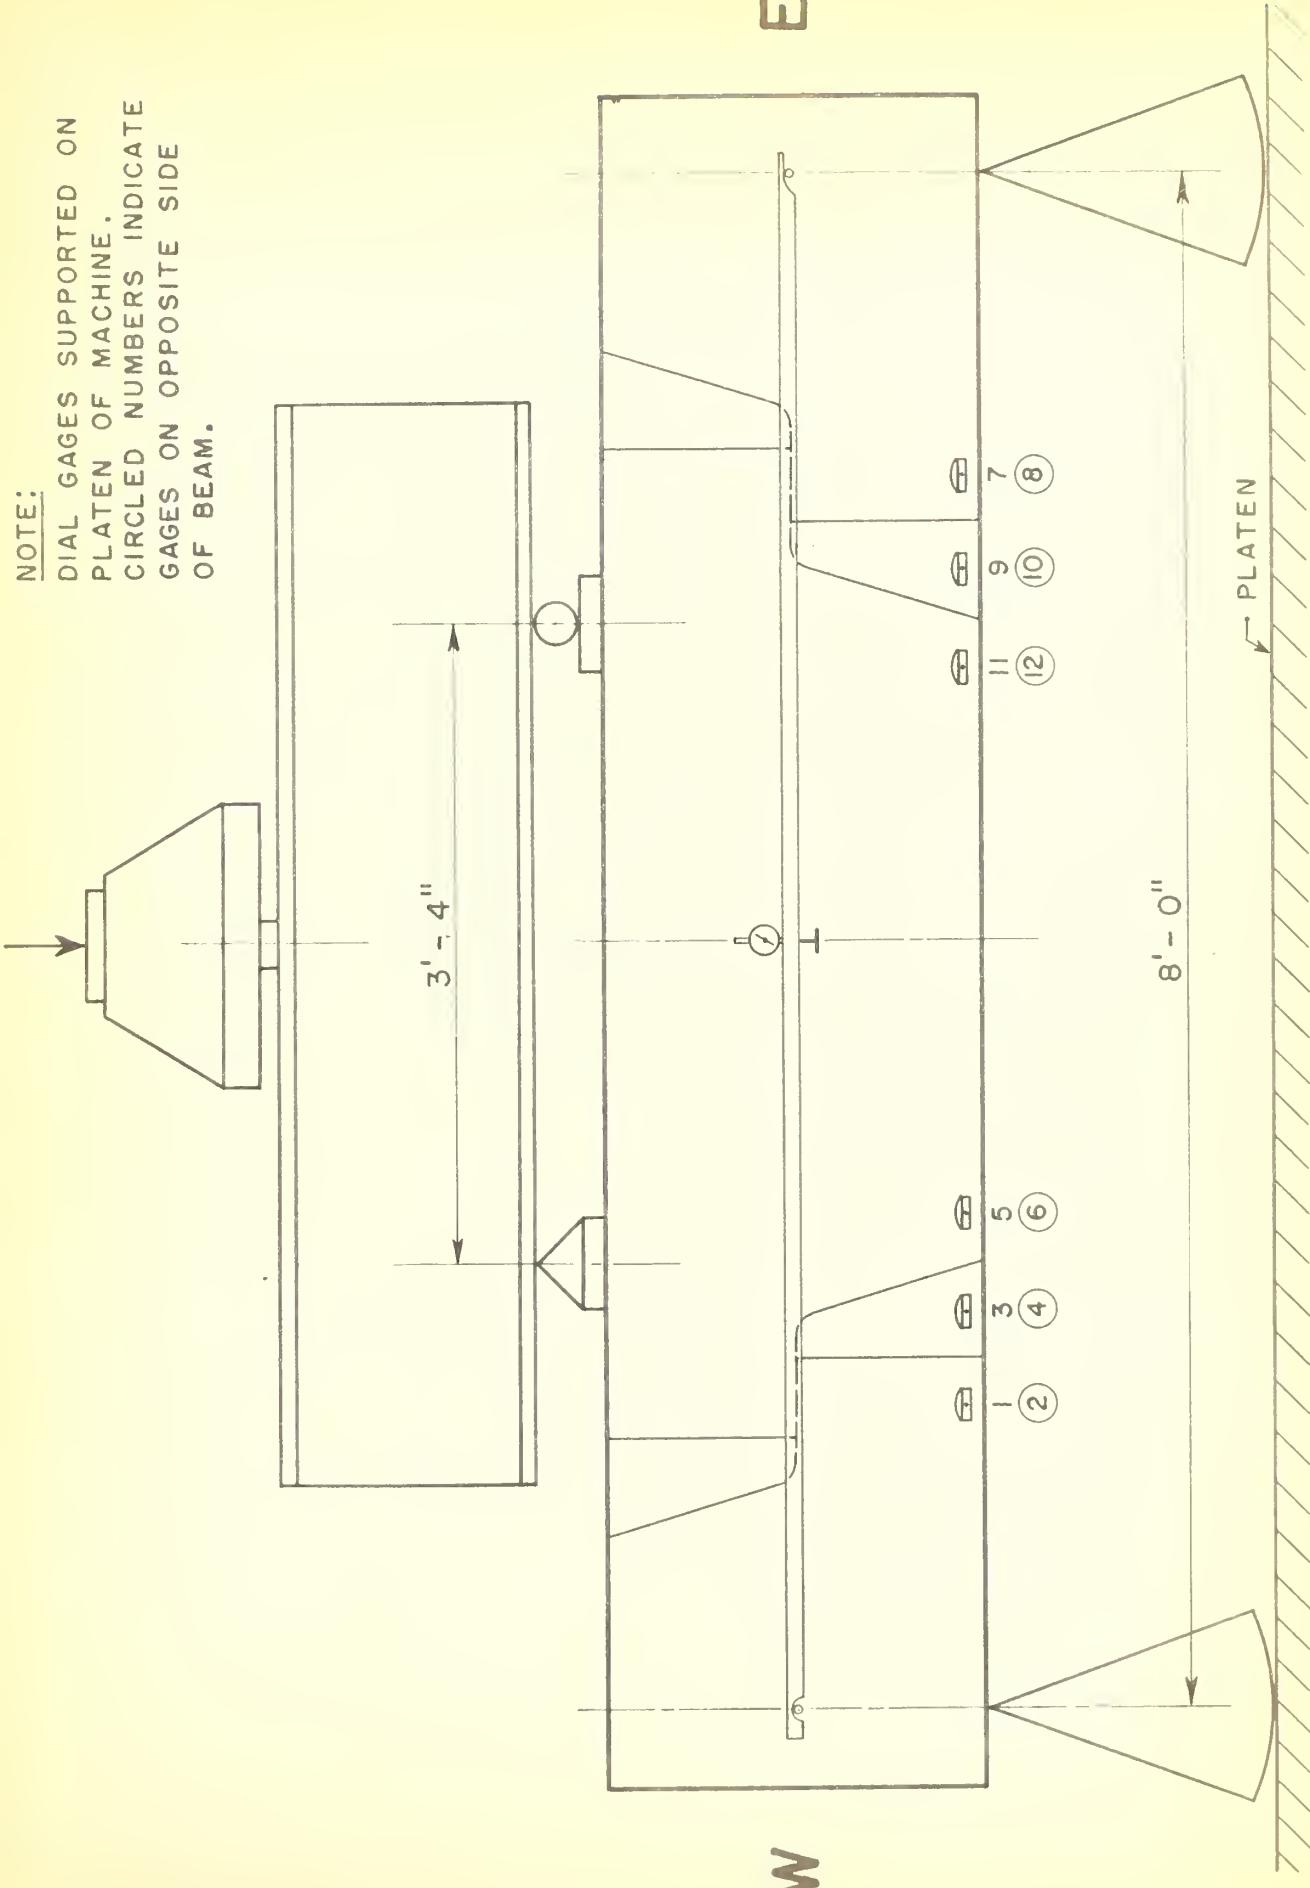
FIG. 2 TEST SETUP

The girders were tested over an 8 ft span in a 600,000 lb capacity hydraulic testing machine. The load was applied applied through a loading beam with a knife edge at one end and a roller-plate assembly at the other. These load points were 40 in. apart and were placed symmetrically about the center-lines of the girders. Figure 2 is a sketch of a girder in the testing machine.

One thousandth inch dial gages with a range of one inch were used for all displacement measurements. Six of these gages were used to measure the lateral displacement of the concrete in the vicinity of each lap welded splice. These gages were supported by ring stands that rested on the platen of the testing machine. The vertical deflection at the center of the girder was measured by a dial gage on each side. These gages were attached to aluminum bars that were supported at their ends directly over the rocker supports of the girder. The location of all dial gages is shown in figure 2.

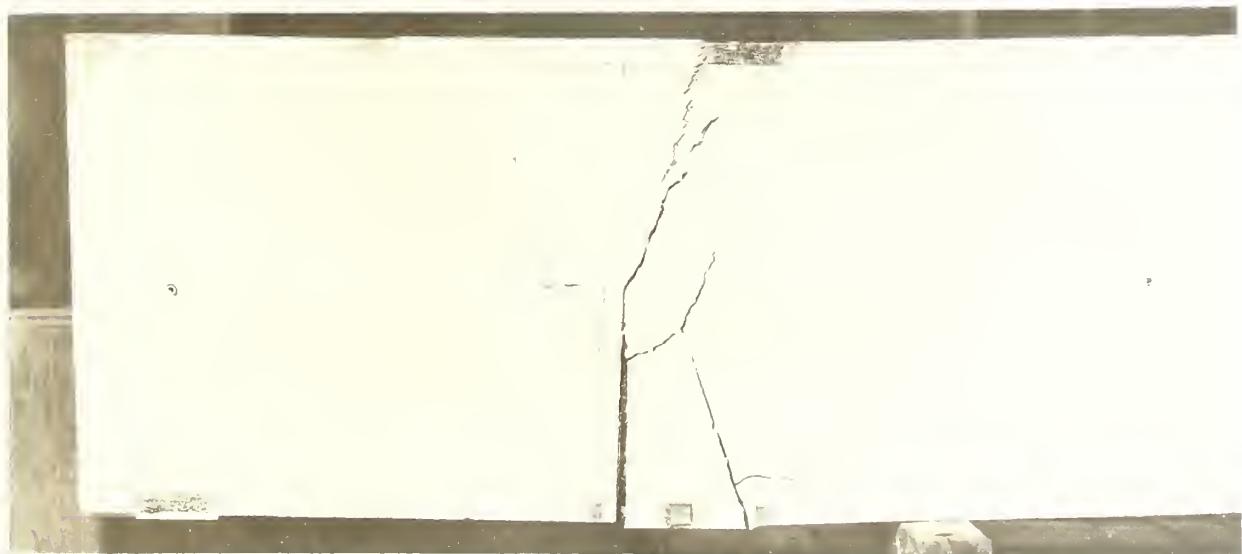
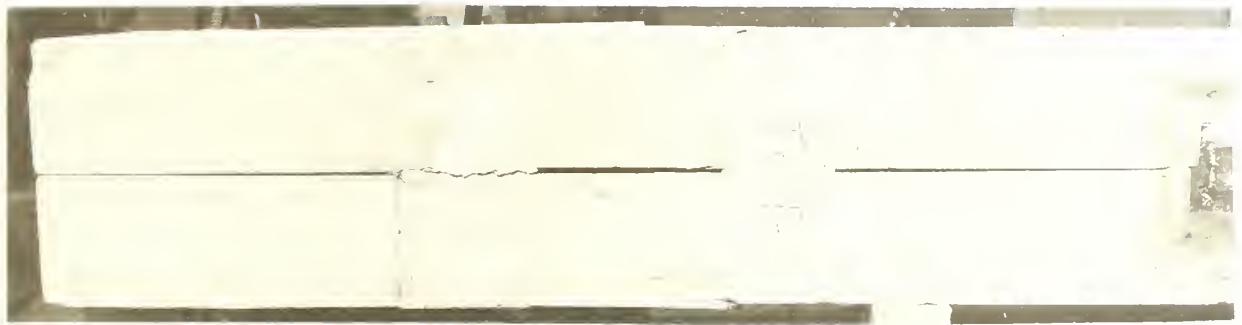
FIG. 3 VIEW OF FAILURE, GIRDER NO. I SOUTHWEST & TOP.

The primary cause of failure in the flexural tests of the girders appeared to be yielding of the tensile reinforcement in the splices. This is indicated by the views of the girders after test in figures 3 through 10 and by the load-strain relationship for girders 3 and 4 shown in figure 11. The views of all girders tested show wide cracks at the straight boundary of the grout pocket. These cracks were sufficiently wide in most of the specimens to reduce the compressive zone of the concrete to a depth which permitted shear failure to occur as a secondary mode of failure.

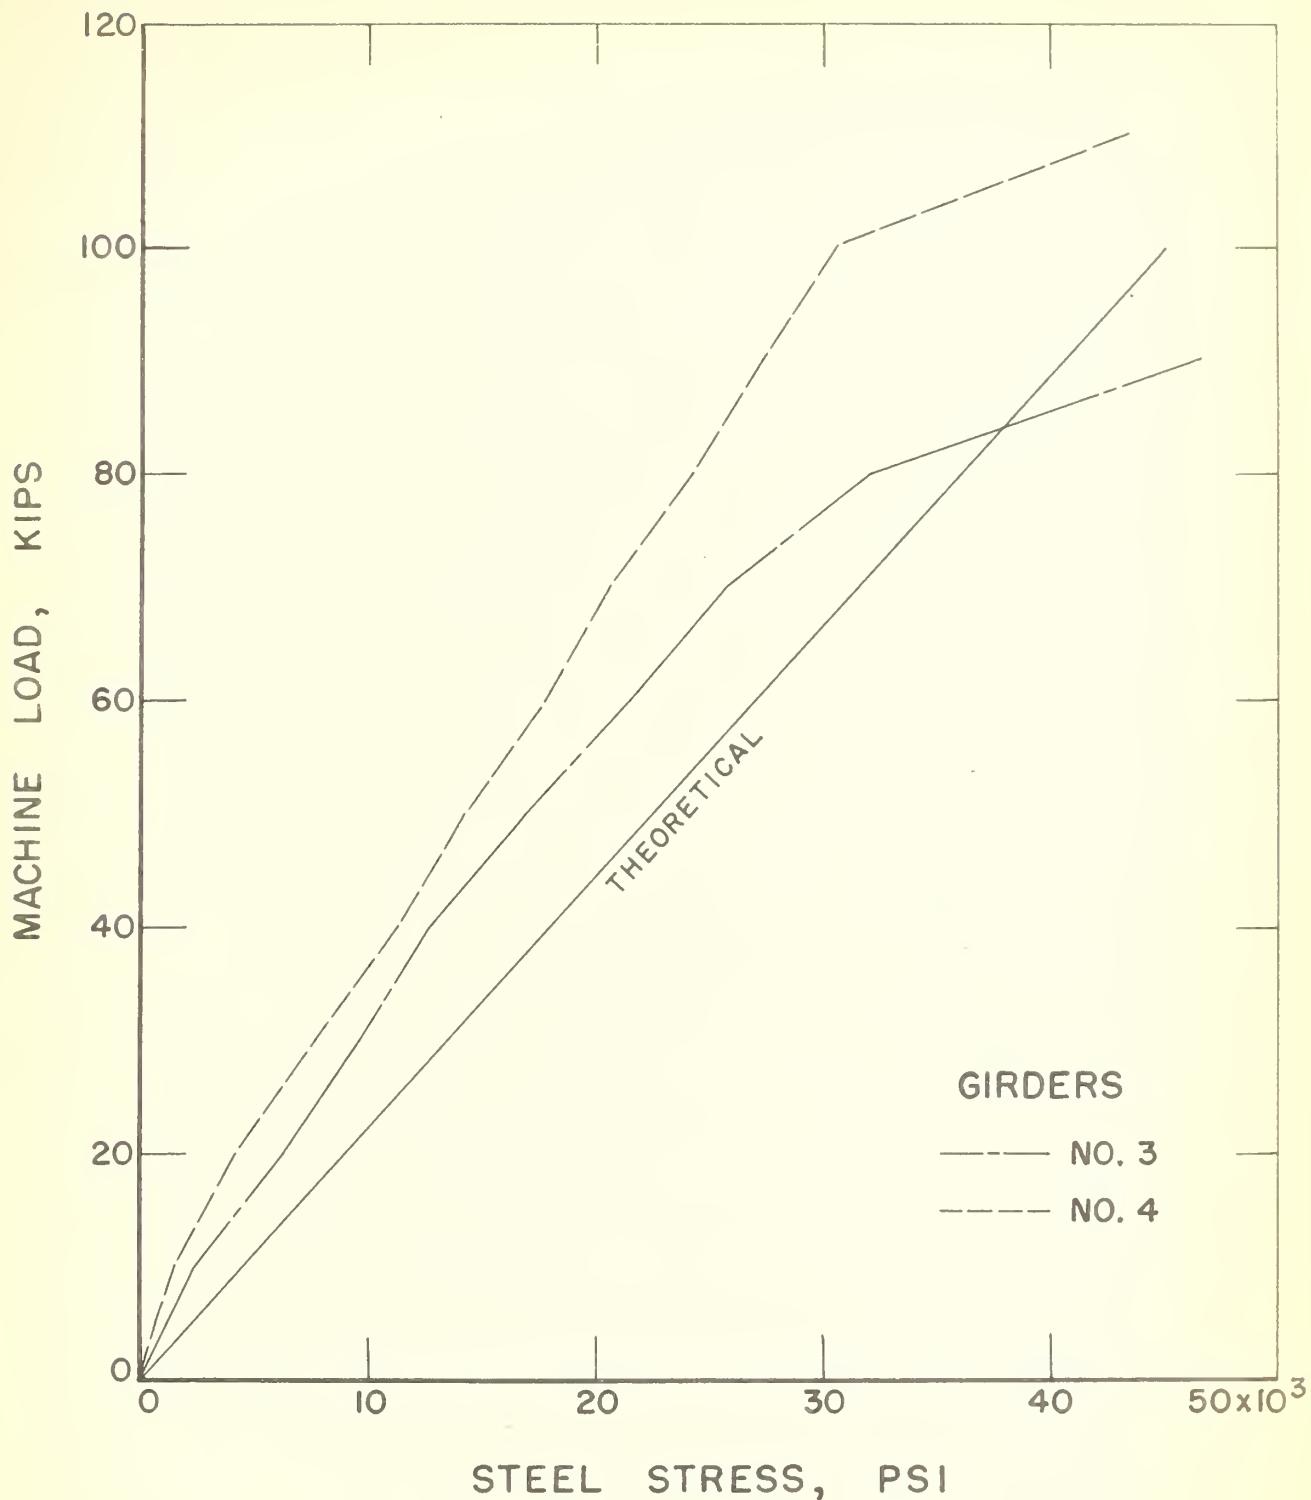
FIG. II OBSERVED AND THEORETICAL STRESSES AT SPLICES
OF GIRDERS NOS. 3 AND 4.

The observed stresses in the longitudinal reinforcing steel at the centerline of girders Nos. 3 and 4 are shown in figure 12. Since the stress at the lap welded splice is of greater magnitude than the stress at the midspan, it is the limiting factor when considering the yielding of the reinforcement. The stresses observed at the lap welded splices of girders 3 and 4 are compared with the theoretical stresses in figure 11.

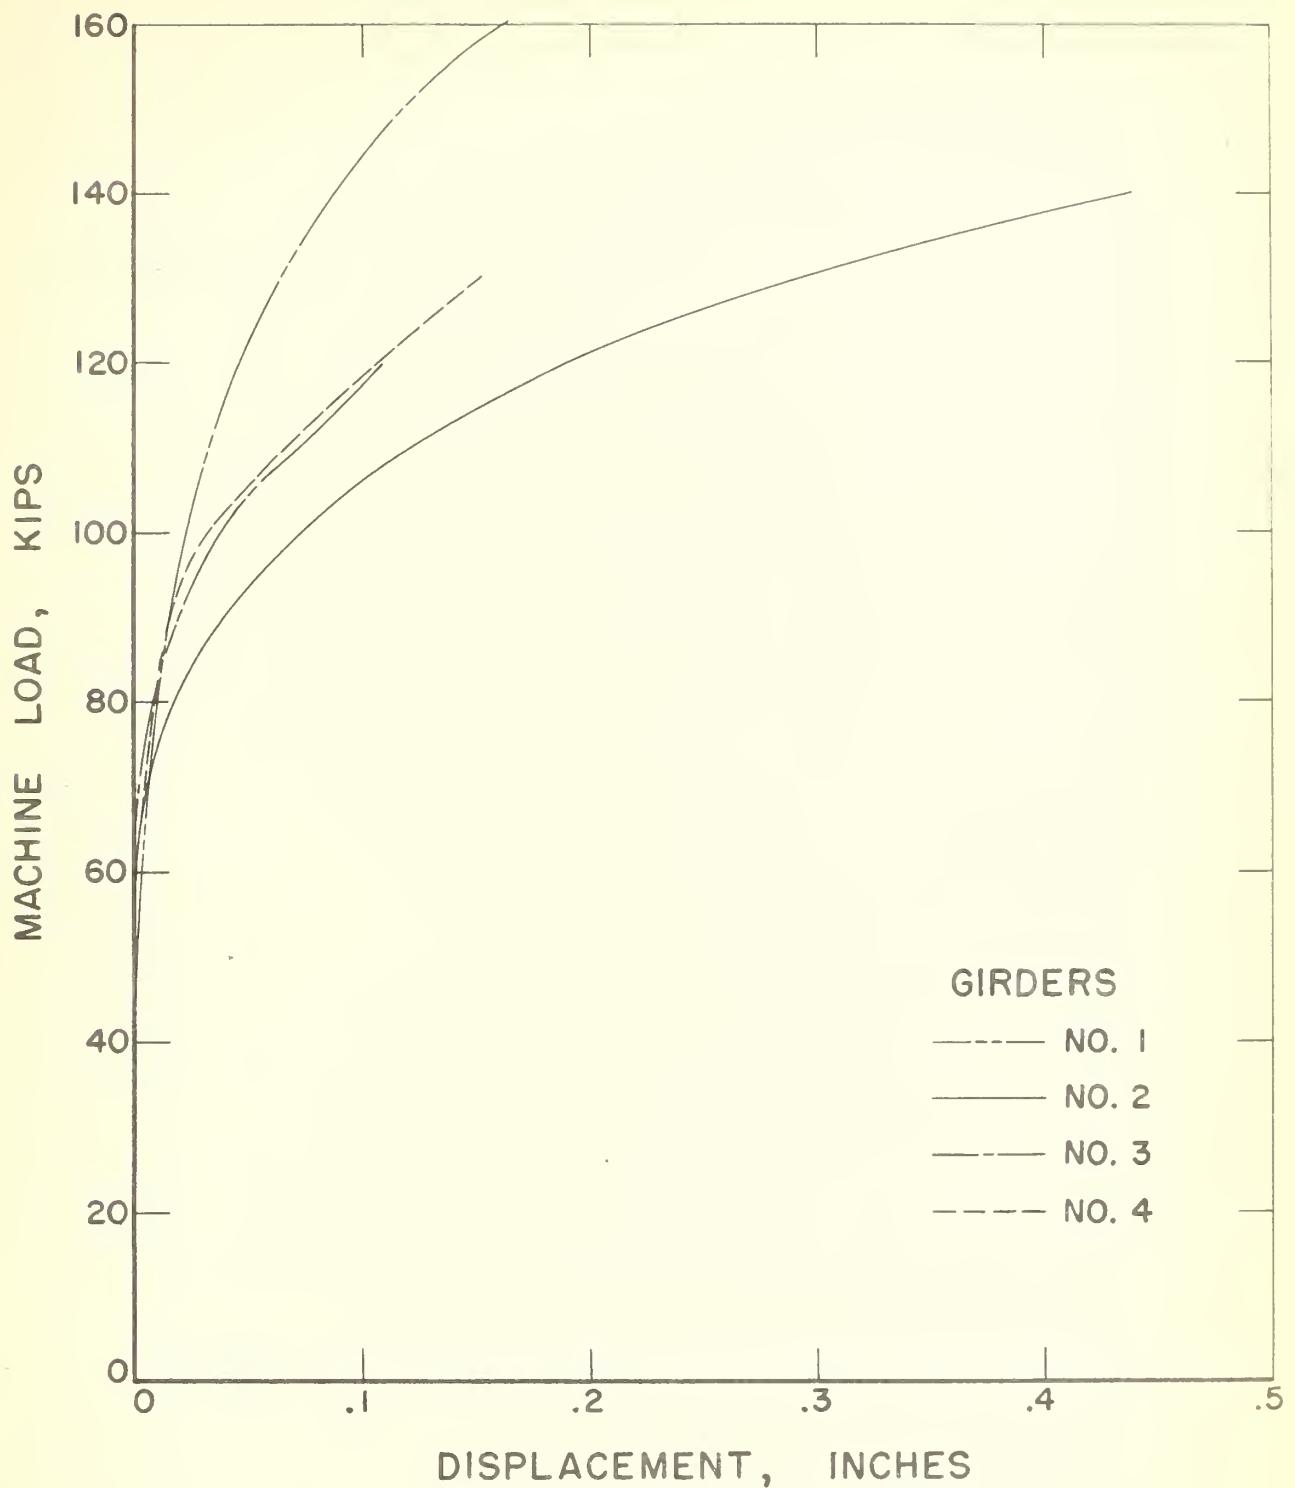
FIG. 13 LATERAL DISPLACEMENT, EAST END SECTION OF ALL GIRDERS.

The lateral displacements of the concrete surrounding the welded splices and the adjoining elements are shown in the diagrams of figures 13 through 18. The load-displacement relationships for all girders are shown in the same manner for each gage position. The values of displacement shown on these curves are the total changes in the transverse dimensions of the specimens calculated as the algebraic sums of the movements measured by gages on opposite sides of the girders.

Comparison of the displacement graphs in figures 13 through 16 shows that for loads exceeding 80,000 lb the lateral movement of the end sections of the girders and of the concrete surrounding the splices was significantly greater for the girder with no transverse reinforcement than for the three girders which contained varying amounts of transverse reinforcement. The theoretical steel stress in the splices at the load of 80,000 lb was approximately 35,000 psi. At higher stresses, the effect of the transverse reinforcement became particularly pronounced in reducing the lateral movement of the concrete surrounding the splices. As can be seen in figures 15 and 16, the maximum observed increases in the transverse dimensions of the splice pockets were about 0.01 in. for girder No. 1, 0.03 to 0.06 in. for girders Nos. 3 and 4 and about 0.25 in. for girder No. 2 which had no transverse reinforcement.

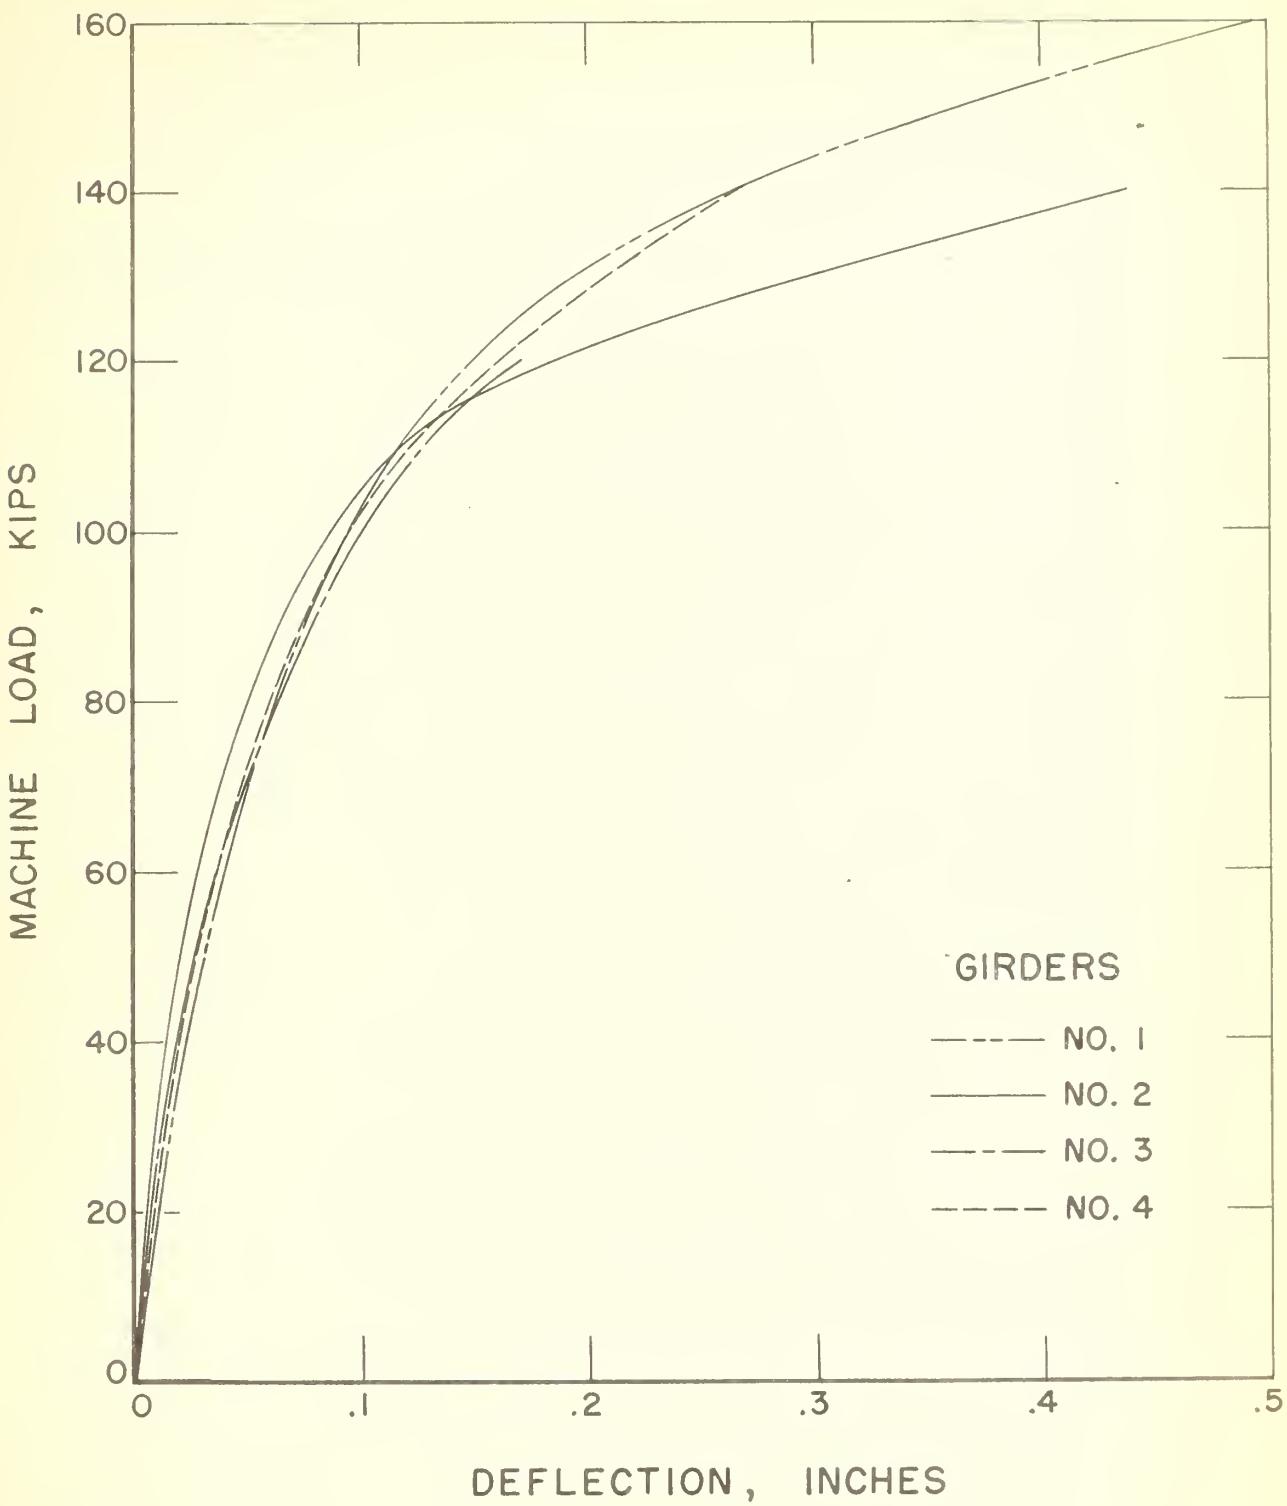
FIG. 19 LOAD VS. CENTER DEFLECTION

The load deflection diagrams for the girders are shown in figure 19. Attention is directed to the fact that the greater rotation of the splices in girder No. 4 had no appreciable effect on the center deflection.

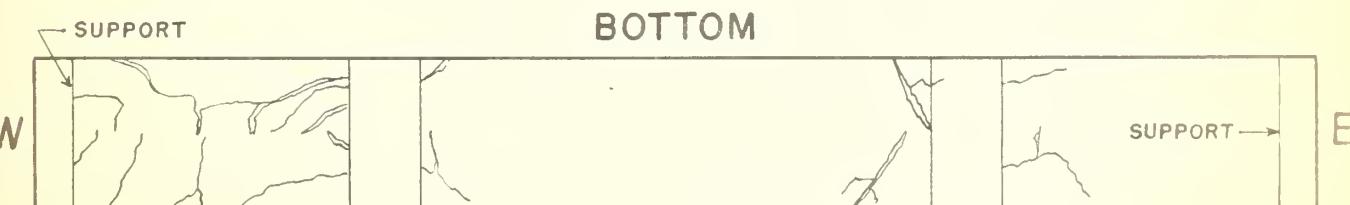
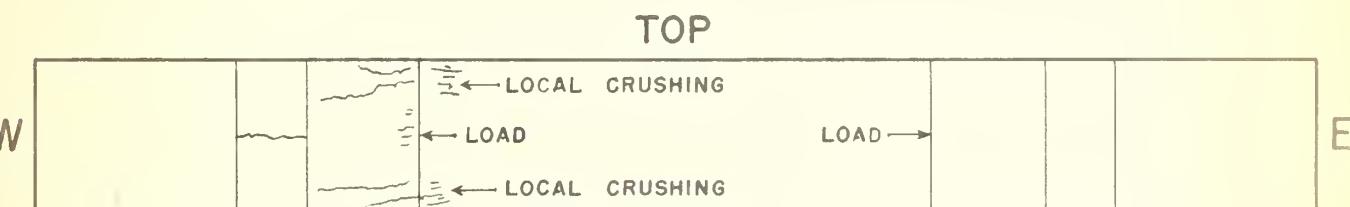
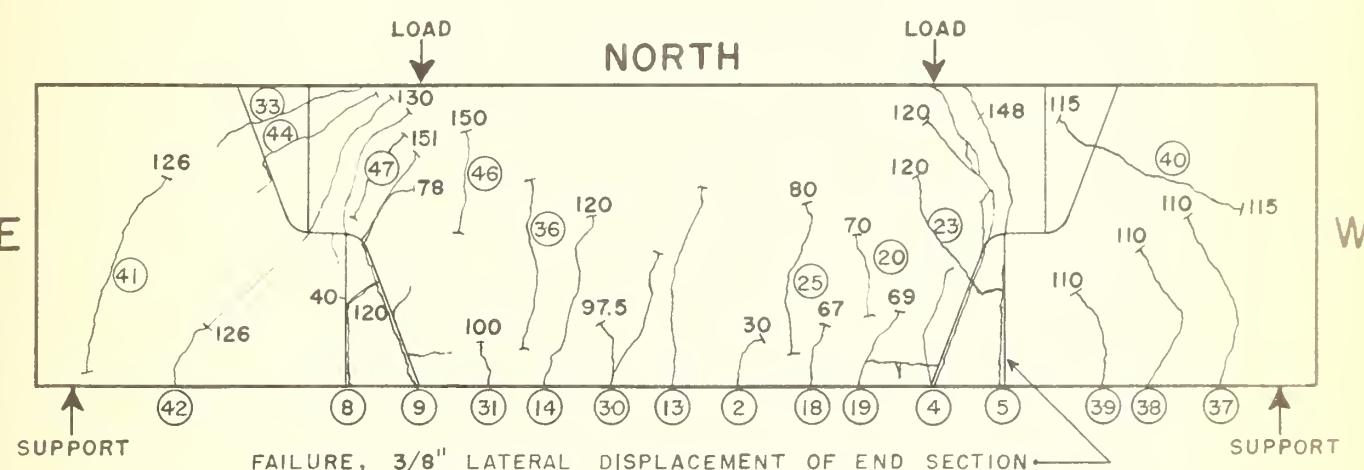
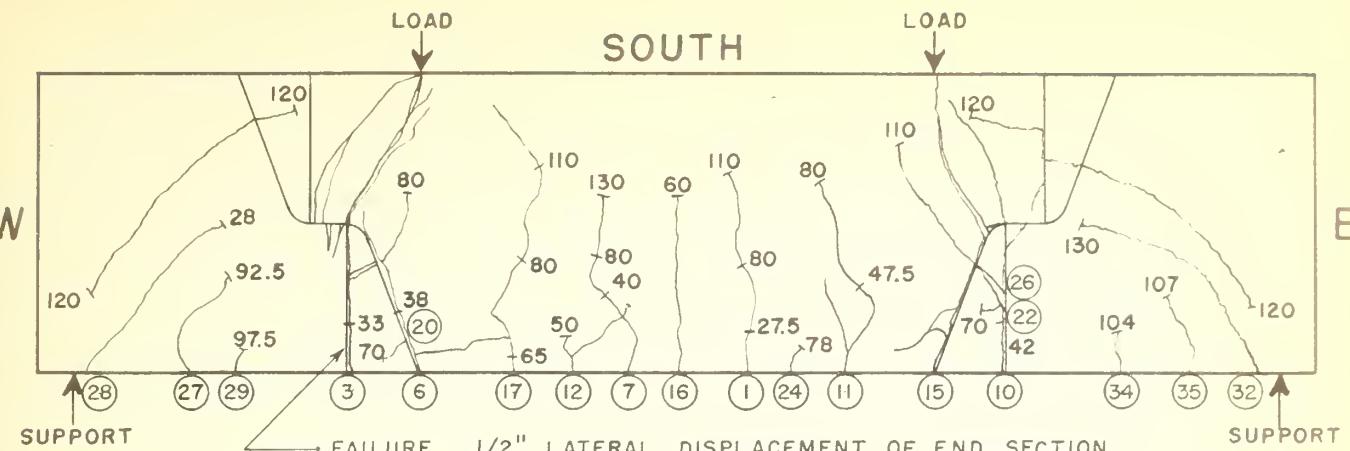
FIG. 20 CRACK PATTERNS, GIRDER NO. I.

Figure 20 through 23 are crack patterns of the girders. The encircled numbers at the bottom of the crack pattern diagrams indicate the order in which the cracks appeared. Due to the fact that the lap welded splices in girder No. 2 rotated, large longitudinal and transverse cracks were evidenced in the concrete pocket while no cracking occurred in the end sections of the girder. Since the transverse reinforcement in girders Nos. 1, 3, and 4, reduced the rotation of the lap welded splices, a wider dispersion of small cracks appeared along their entire length.

It is concluded that a small amount of transverse reinforcement in the splices is well worth the slight additional cost in order to guard against excessive rotation of eccentrically tensioned lap welded splices and the accompanying lateral displacement of the concrete in the splice pockets which are observed at steel stresses in excess of 35,000 psi.
